Mobile Intel[®] Pentium[®] II Processor Specification Update

Release Date: July 2002

Order Number: 243887-042

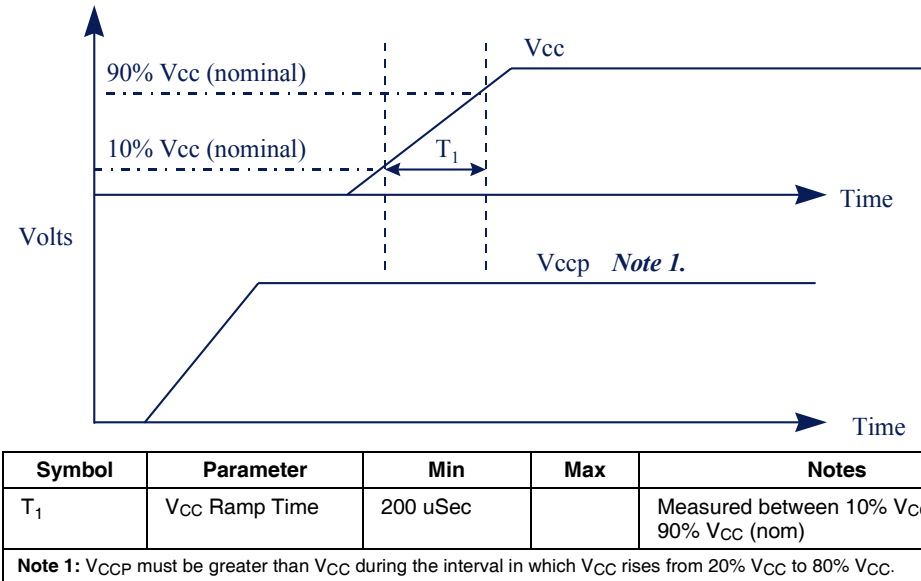
Figure 1. V_{CC}/V_{CCP} Timing Requirements (Mobile)

Problem: The processor uses the PWRGOOD signal to ensure that no voltage sequencing issues arise; no pin assertions should cause the processor to change its behavior until this signal is asserted, when all power supplies and clocks to the processor are valid and stable. However, if V_{CC} ramps up before V_{CCP} , it will cause the processor to enter an invalid state.

Implication: If this erratum occurs, the system may boot normally however, the L2 cache may not be initialized.

Workaround: For Mobile Pentium II processors, ensure that V_{CC} ramps after or with the L2 cache IO voltage (V_{CCP}). If V_{CCP} ramps after the V_{CC} , a delay circuit can be placed on the core V_{CC} to ensure that V_{CC} ramps at the same time or after V_{CCP} as shown below in Figure 1.
